2010 PGOLID Stream Monitoring Summary

Compiled by Moriya Rufer, PGOLID Water Resource Coordinator

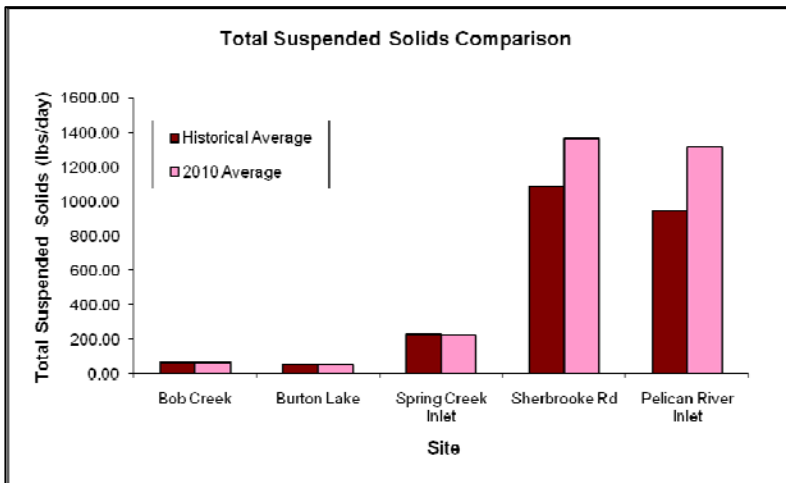
Figure 3. Total suspended solids loading at each site comparing the historical average to the 2010 average.

The Bob Creek Watershed includes two monitoring sites, Bob Creek and the Burton Lake outlet. This watershed showed water flows consistent to historical averages (Figure 1). This resulted in total phosphorus and total suspended solids loading that is consistent with historical averages (Figures 2 and 3).

The Pelican River Inlet showed slightly higher water flow in 2010 than historical averages (Figure 1). This resulted in total phosphorus and suspended solids loading that was slightly higher than historical averages (Figures 2 and 3). Precipitation records show higher than average rainfall for 2010, which is most likely the reason for the higher flow.

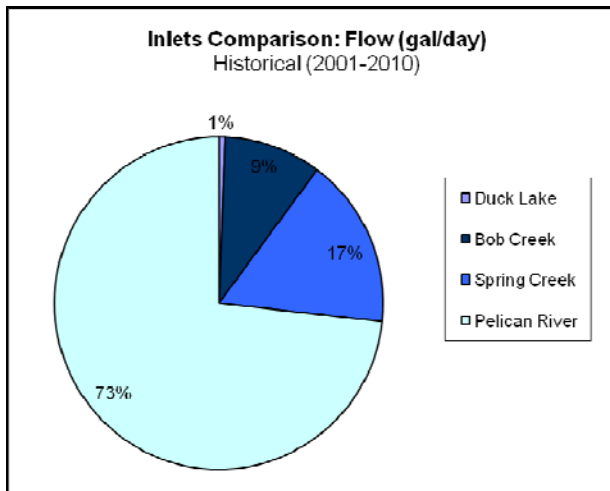
Figure 4. Historical inlet flow proportions for Pelican Lake inlets

Historically, 73% of the water flowing into Pelican Lake comes from the Pelican River, 17% from Spring Creek, 9% from Bob Creek, and 1% from Duck Lake (Figure 4). In 2010, Bob Creek contributed 1% increase in water flow historically (Figure 5). Also, Spring Creek, increased 1% of the flow entering Pelican Lake in 2010, causing the Pelican River to decrease to 72% of the flow. This increase in Spring Creek flow is most likely due to the fact that the Cormorant Lake outlet control structure was discharging water all summer, which wasn't the case in the past.

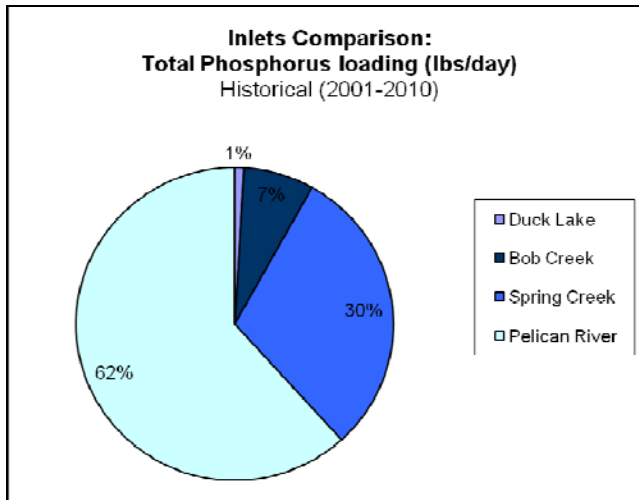
Figure 6. Historical inlet flow proportions for Pelican Lake inlets

The phosphorus loading into Pelican Lake mirrors the flow in comparing historical phosphorus loading levels to 2010 levels (Figures 6-7). The increase in flow in Spring Creek translated to an increase in phosphorus loading into Pelican Lake from Spring Creek in 2010.

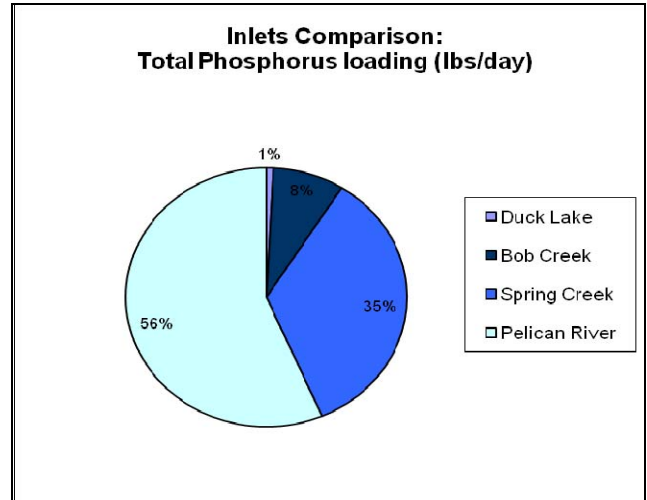
Figure 7. 2010 inlet flow proportions for Pelican Lake inlets

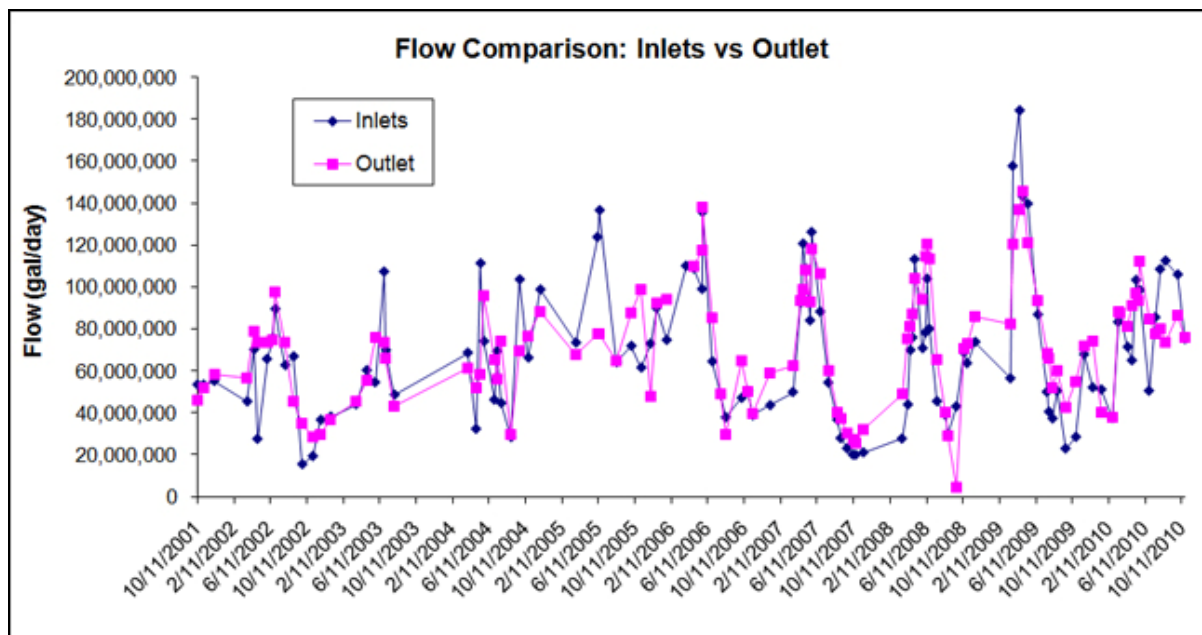
Figure 8. Historical inlet versus outlet flow in Pelican Lake.

The outlet flow follows the inlet flow, which keeps water levels fairly regulated (Figure 8). In addition, the phosphorus coming into and out of the lake follow each other, which means that extra phosphorus is not remaining in the lake (Figure 9). These results are good for water quality. If extra phosphorus was remaining in the lake, it would feed additional plant and algae growth.

The peaks in flow and phosphorus loading occur in the spring months, April-May, and are most likely attributed to spring thaw.

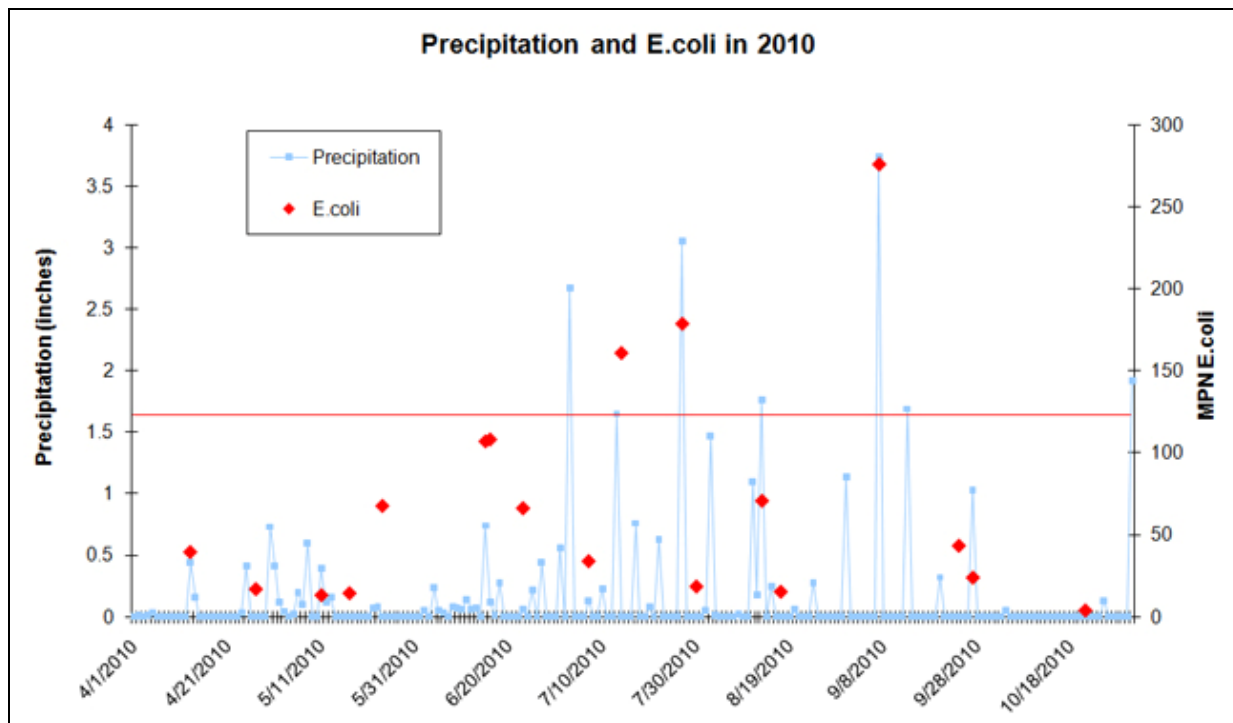
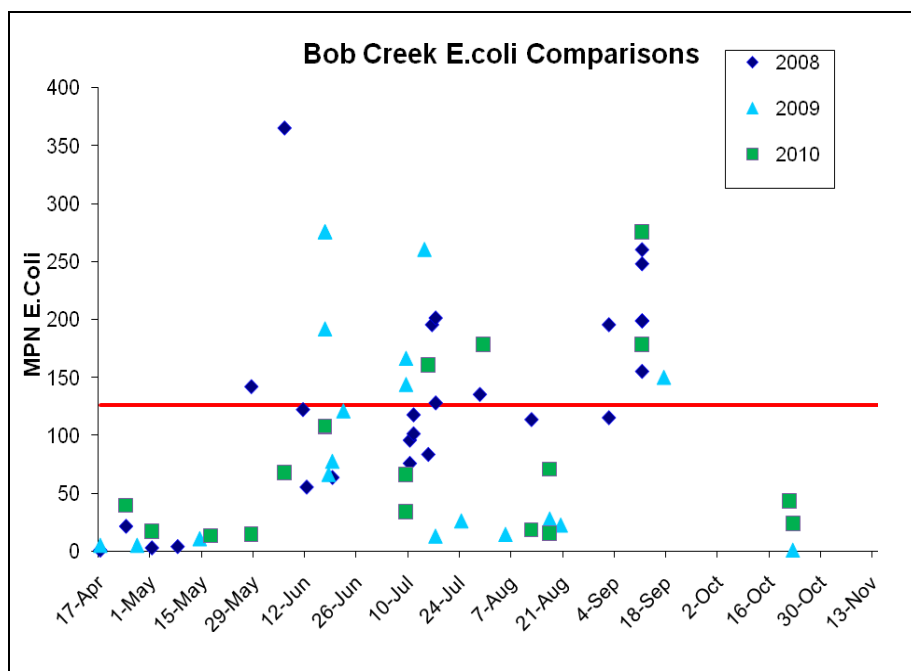
Bob creek monitoring in 2010 was consistent with previous years, if not slightly better. The high *E. coli* counts were measured during or after large rain events (over 1 inch). Therefore, as far as human safety, residents should not swim in Bob Creek on or 1-2 days after a rain event of over 1 inch.
